Creston and District Community Complex

James Ross Memorial Pool

Pool Condition Assessment &

Upgrade Feasibility Study

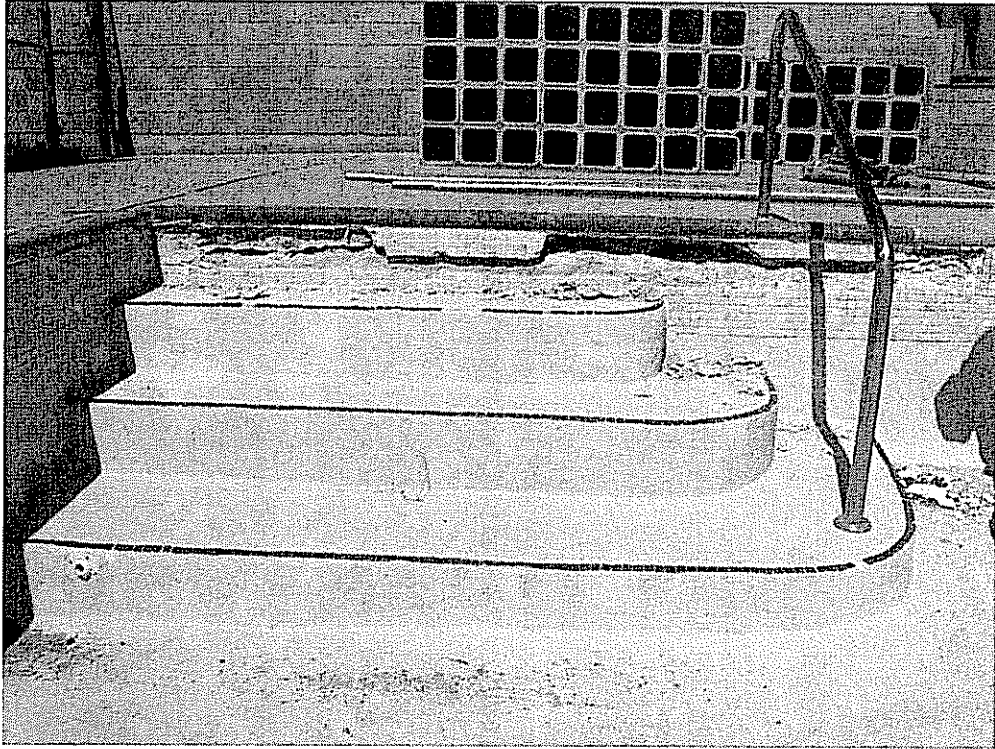
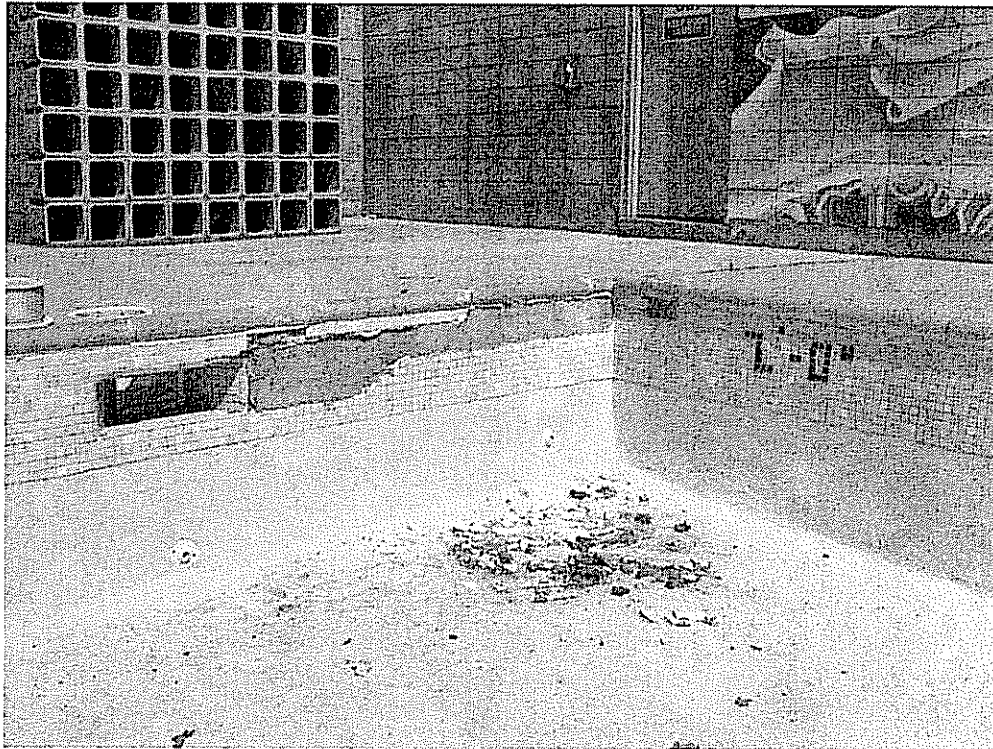
The concrete pool tank has deteriorated along the top of the walls and the tiles and plaster have pulled away exposing the pool shell. The exposed concrete pool shell is in poor condition (see appendix photos 1 & 2). It appears water has migrated between the shell and the plaster causing hollow areas and cracks that have required numerous repairs over the years. The cracked floor plaster and tiles cause a high rate of cuts to pool patron feet, estimated at 10+ injuries per day while the pool is in use.

- 6) Broken tiles and plaster finish very rough with sharp edges and hazardous to bathers. Current reported injury rate is unacceptable.
- 7) During times of heavy use, the pool staff has a difficult time maintaining healthy water quality without the aid of an automated system similar to the Acutrol system used for the large swimming pool.

Photos 1 & 2: Wading Pool wall deterioration and tile damage

- 5) Pool shell to be repaired with concrete mortar and grout, cracks to be filled, all sharp edges to be sanded down and new tiles, plaster and/or epoxy pool paint to be applied.
- 6) Repair or replace wading pool coping with new poured in place coping.

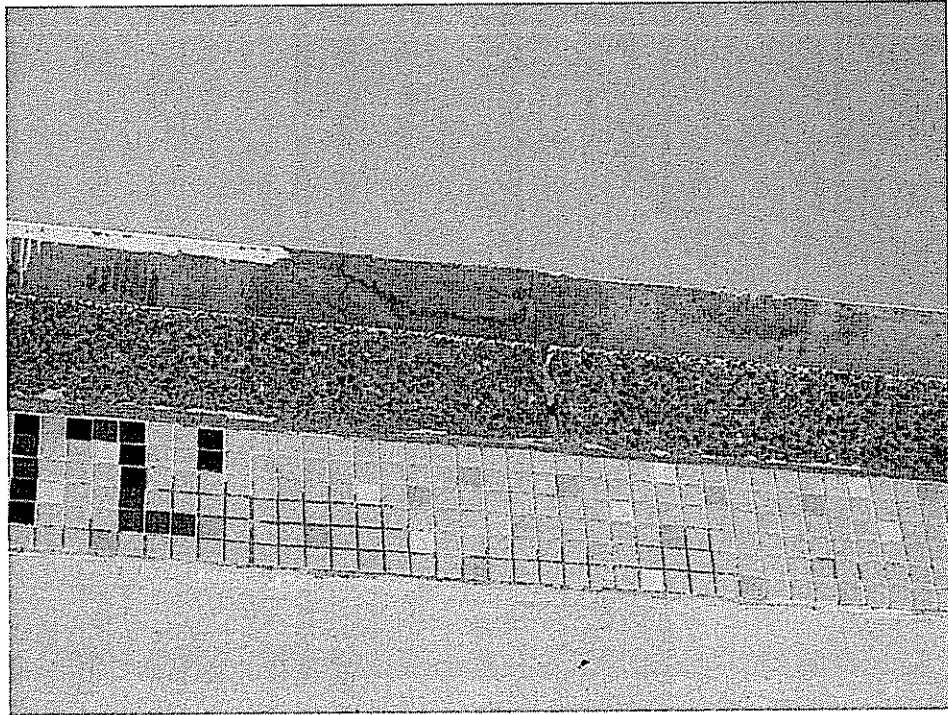
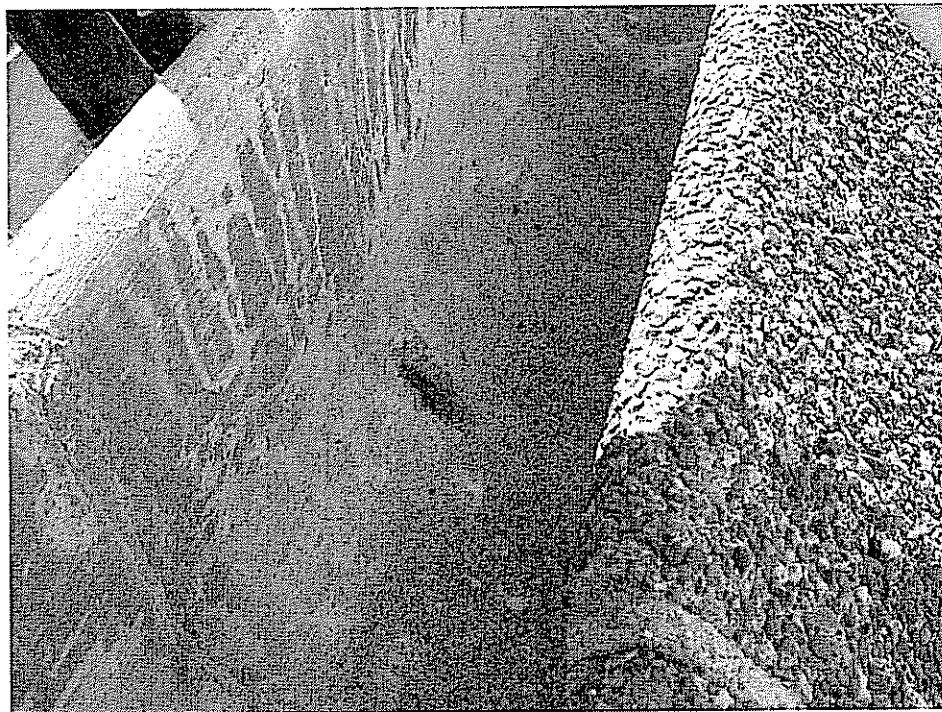
The rim flow gutter system is made of pre-cast blocks that have deteriorated to the point that there are sections breaking off and rebar is now exposed. Water has penetrated around the gutter blocks and caused tiles to lift and pull away from pool shell. Tiles and broken gutters have created many sharp edges causing a reported 5+ hand injuries to bathers per day while pool is in operation (see appendix photos 3 & 4).

- 9) Pre-cast rim flow gutter condition causes sharp edges; uneven joints and exposed reinforcing create hazardous conditions and reported high injury rate to bathers' hands.

Photos 3 & 4: Swimming Pool pre-cast gutter deterioration

- 7) Remove and replace damaged floor and wall tiles.
- 8) Remove and replace pre-cast rim flow gutter system with new poured in place gutter. Remove existing gutter pipe. Provide 18 equally spaced drains in gutter connected to new 4" diameter continuous looped pipe.
- 9) Pressure test existing pipe and if all is well, tie new gutter pipe into existing pipe line that runs to pool equipment room.
- 10) Provide warning sign for 3 meter diving board users and establish maintain strict rules governing use of 3 meter board or remove 3 meter board.
- 11) Repair surge tank structure and apply new protective waterproof coating inside tank.

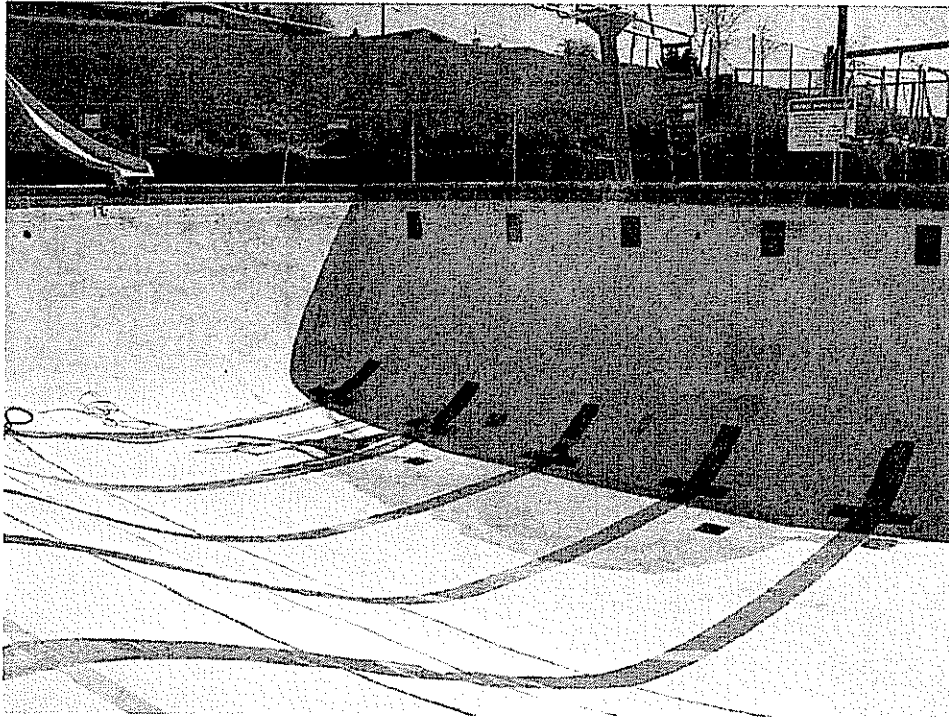
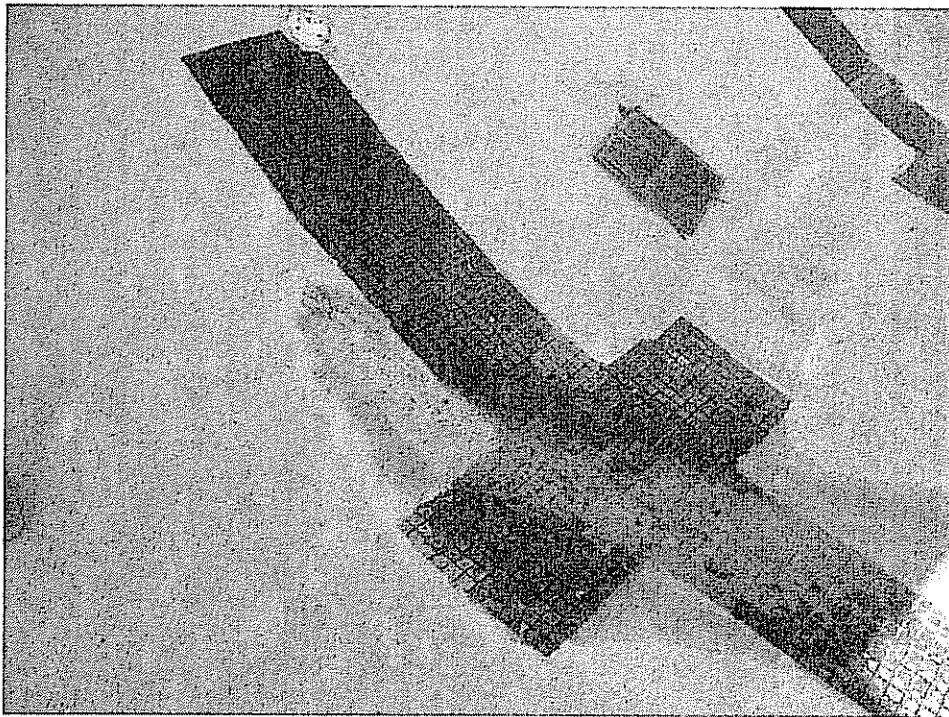
The concrete pool tank has deteriorated and cracked over the years and has had numerous repairs. There are areas in deep end of pool where the shell has deteriorated to the point that ground water is visibly seeping through concrete and plaster finish (see appendix photos 5 & 6). The number of areas has increased from 3 in 2000 to 9 in 2006. Water caught between pool shell and plaster has caused tiles to lift and plaster to crack, creating a hazard for bathers' feet.

- 10) Pool structural integrity has been compromised at deep end. Large void areas under pool most likely exist due to leaking pipes releasing excess water, washing away soil and adding to the deterioration of the shell. Life expectancy and full extent of shell damage is unknown, but is obviously deteriorating at a significant rate based on the increased "weeping" areas over the past six years. Excessive water loss through main outlet piping will continue to wash away soil and erode pool shell.

Photos 5 & 6: Swimming Pool diving tank ground water seepage

- 5) Repair pool shell in deep end and modify profile to comply with current 3 meter diving standards. This would require major modifications to existing pool structure.
- 6) Replace existing DE filter with new Horizontal sand filter.
- 7) Replace surge tank with new structure complete with protective coating.
