D.R.NICOL GEOTECH ENGINEERING LTD.

Springer Creek Fire
Number 50372
Long-term Risk Analysis

Prepared for Ministry of Forests and Range
Southern Interior Forest Region
March 17th, 2008

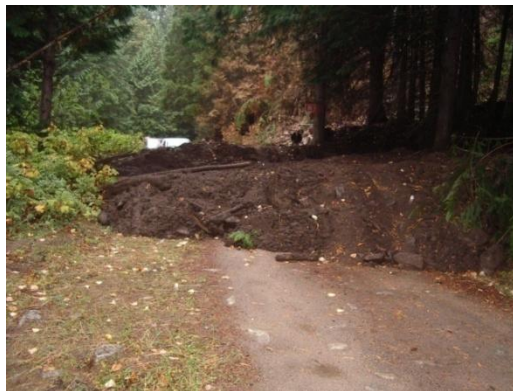
Photo 7 N Ent 2 part of debris flow deposit

On August 31, 2007 (reported September 3 but thought to have occurred the night of August 31), a debris flow occurred within drainage unit N Ent 2 – a tributary (at 5km) to Enterprise Creek (see Photos 3 to 7). The drainage area of drainage unit N Ent 2 is 123 hectares of which 88% was burned to a moderate or high severity. Only 2.2mm of precipitation was recorded at the Slocan weather station on the evening of August 31. Data of the rainstorm was collected from 3 of the weather stations that were installed by MFR in the burn area during August 2007. The first station was located at an elevation of 1726m in the Allen drainage unit, the second station was located at an elevation of 1593m in the Cory drainage unit and the

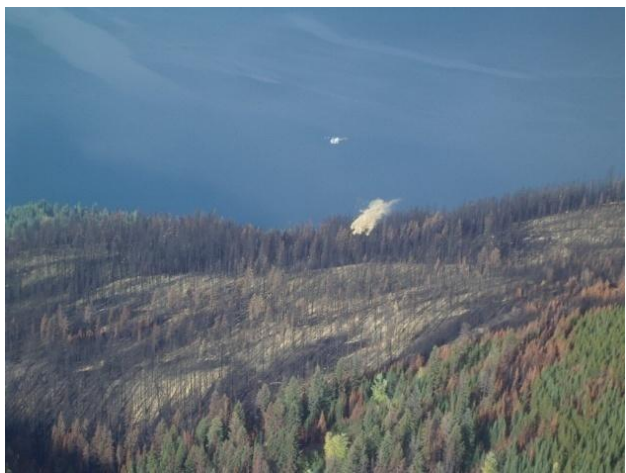
Photo 10 Helimulch drop

Subsequent to the Springer Creek Post-Wildfire Risk Analysis (Nicol et al 2007), several hazard mitigation strategies to reduce short-term risks were implemented by MFR and MOT. MFR completed helimulch treatments of some of the moderate and high severely burned areas located on moderately steep slopes above identified elements at risk as per a hill slope soil mitigation treatments proposal by Curran et al 2007. The helimulch was applied by dropping bales of straw from helicopters. A map of the helimulch treatment areas is shown in Photo 9 and photos of the process of applying the mulch is shown in Photos 10 and 11.

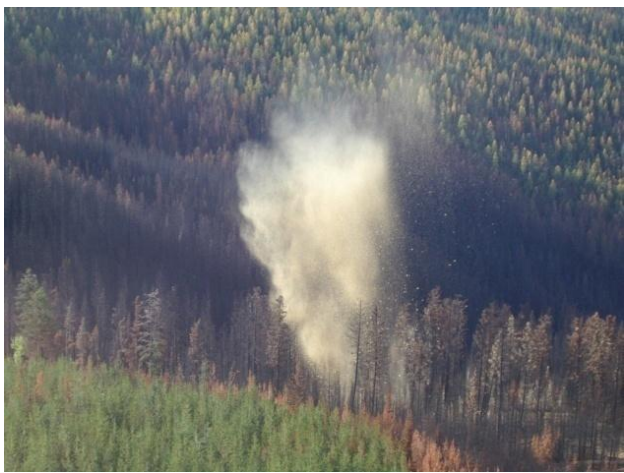
Photo 11 Helimulch break up before ground impact

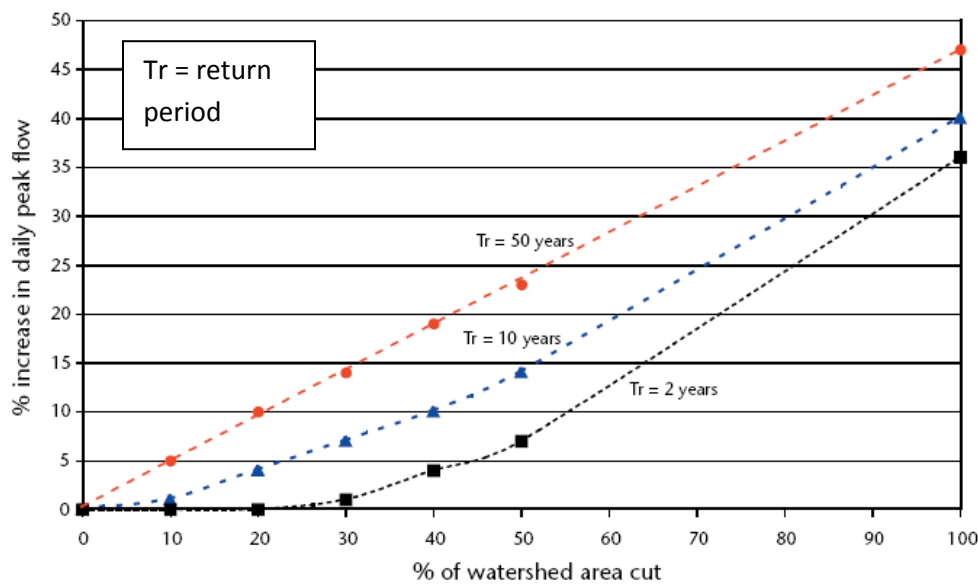
Figure 4 From Schnorbus et al 2004

The DHSVM model was used by Schnorbus et al 2004 to model 241 Creek northeast of Penticton (located 140km to west of Springer Fire) which is a 480 hectare watershed with an elevation range of 1600m to 2025m. The model correlated the percentage of a watershed area cut to the percentage increase in daily peak flow. The DHSVM was compared with field measurements of creek hydrographs, snow accumulation and melt rates, rainfall interception, tree transpiration, and differences in soil moisture. The results of the study indicated that the changes in daily peak flows (as a result of harvesting) vary depending on the return period and percentage of watershed cut. Some sensitivity was observed to the elevation of the harvesting with increasing changes in the higher elevations (see Figure 4). When 50% of the watershed is harvested, changes in daily peak flows ranged from 7 to 23% depending on the return periods. For 100% harvesting changes in peak flows ranged from 36 to 47%.

The results of the study suggest that even with 100% clear cutting of the drainage the change in peak flows are limited to below 50%.

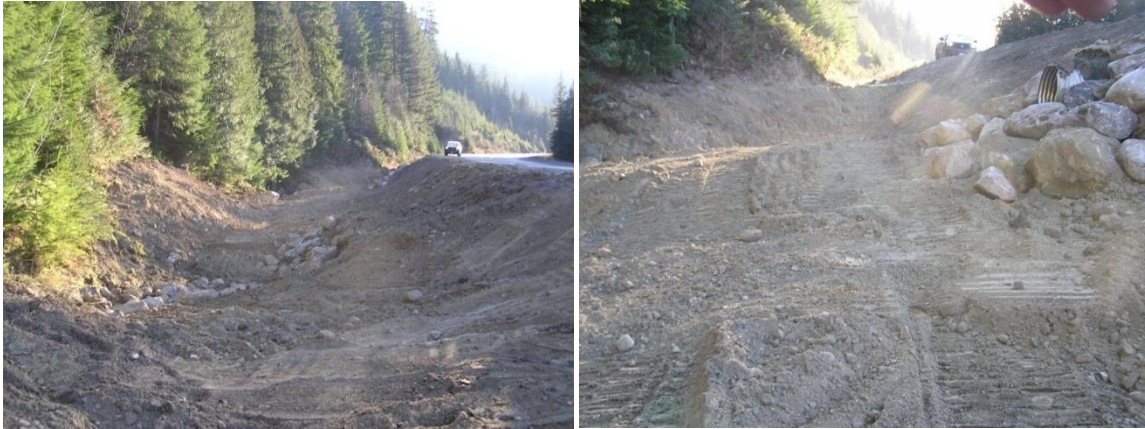
Photos 13 and 14 Additional debris flow storage volume and new overflow culvert installation above highway near middle Van Tuyl Creek

The high risks shown in Table 7 are associated with the debris flow prone gullies located adjacent to the highway. As noted above, in order to mitigate the short term risk MOT has widened the ditch below drainage units R6 and R7 to improve rock fall catchments, has replaced a culvert at the Ent 1 creek crossing, has installed 2 new overflow culverts in the Van Tuyl Creek crossings, and has created additional debris flow storage capacity above the Van Tuyl creek crossings by removing over 1000m³ of material (see Photos 13 and 14).

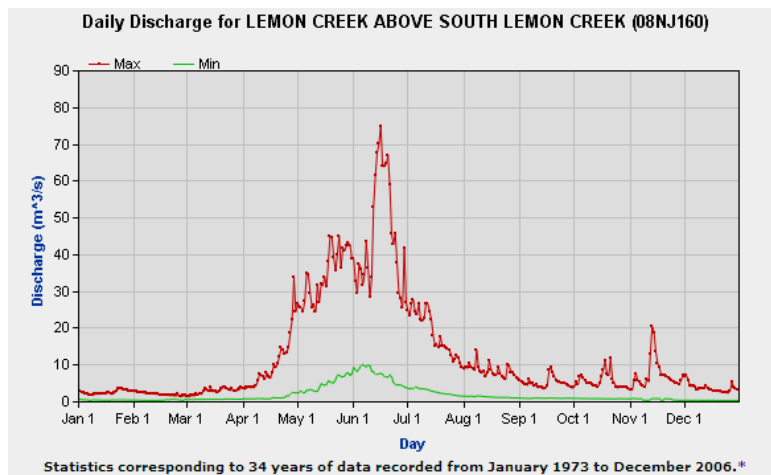
Figure 8 Lemon Creek daily discharge From Water Survey Canada

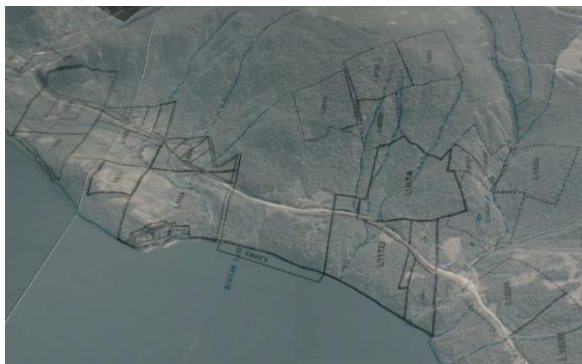
Photo 15 Cadastral overlay onto terrain Memphis to Enterprise Creeks

The Regional District Central Kootenay (RDCK) Cadastral map (surveyed lot boundaries) with the BARC fire severity polygons is shown in Figure 7. Photo 15 shows the RDCK cadastral boundaries

including mineral claims (dotted lines) overlain onto 3d imagery.
